Balcony Inspection Report

Table 2 Summary of Findings

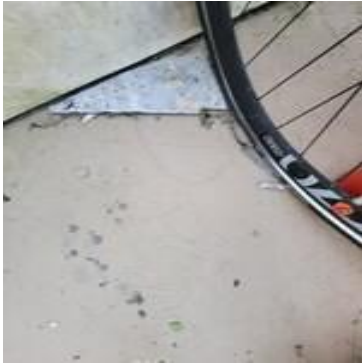
Picture 91: Surface of stairway

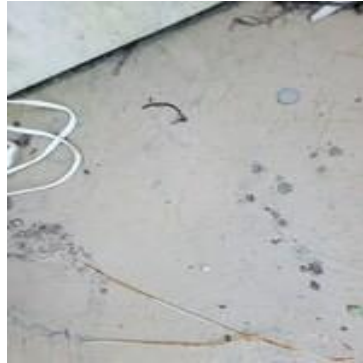
Picture 92: Surface of stairway

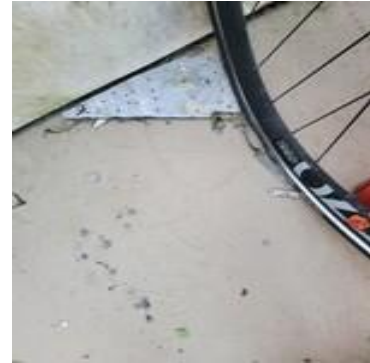
Picture 93: Surface of stairway

Identified defect (1): Surface114

Issue: Open Stairway Rise Non-Compliance with Latest Code - Grandfathering Consideration

Characteristics: The stairway rise of the existing structure features an open design, which does not meet the requirements of the latest building code. This open design might refer to an absence of risers or other features that provide a continuous enclosure for each step. However, the structure may have been built before the latest code went into effect and could be considered under grandfathering provisions.

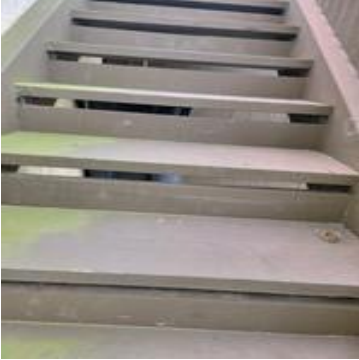
Picture 94: Surface of stairway

Identified defect (2): Surface1

Characteristics: Small, superficial cracks on the wood surface.

Impact: Primarily cosmetic; does not affect structural integrity.

Recommendation: Fill cracks with wood putty or filler, sand, and refinish if desired.

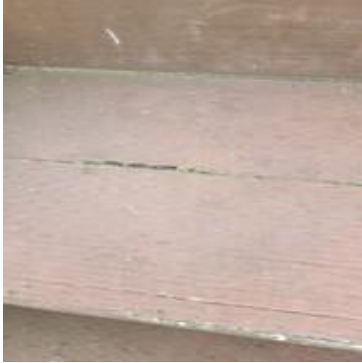
Picture 95: Surface of stairway

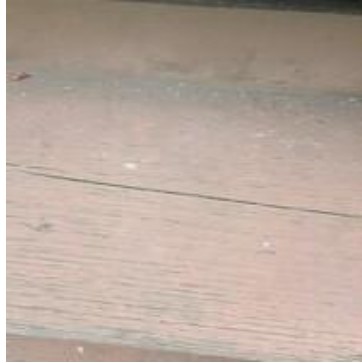
Picture 96: Surface of stairway

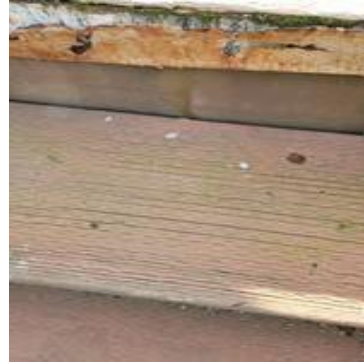
Picture 97: Surface of stairway

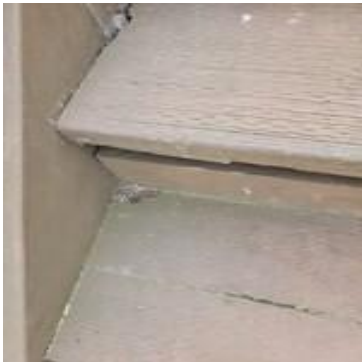
Picture 98: Surface of stairway

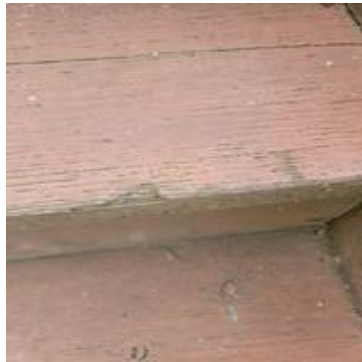
Picture 99: Surface of stairway

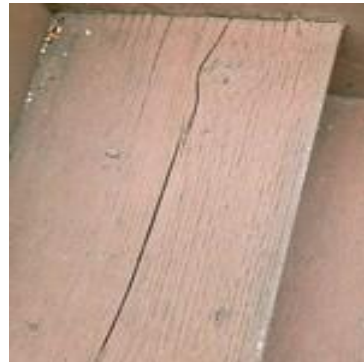
Picture 100: Surface of stairway

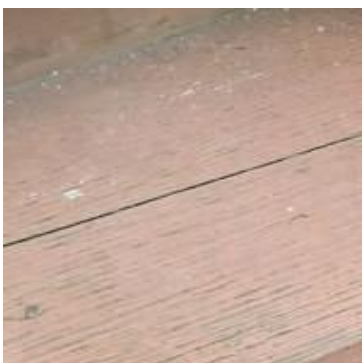
Picture 101: Surface of stairway

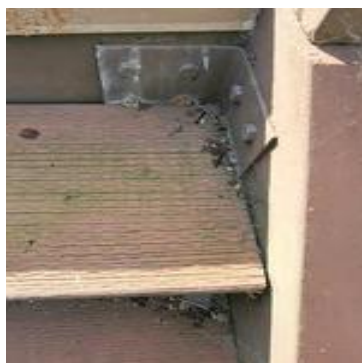
Picture 102: Surface of stairway

Identified defect (3):

Surface3 Issue: Peeling Paint
or Finish

Characteristics: delamination or detachment of paint or finish.

Impact: Exposes wood to the elements, potentially leading to deterioration.

Recommendation: Remove loose paint or finish, sand, and reapply a suitable coating for protection.

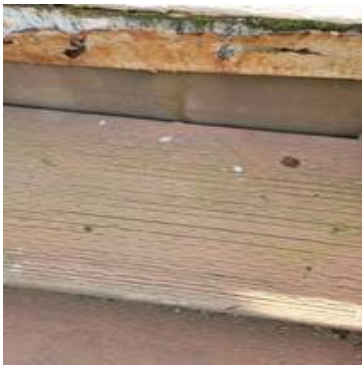
Picture 103: Surface of stairway

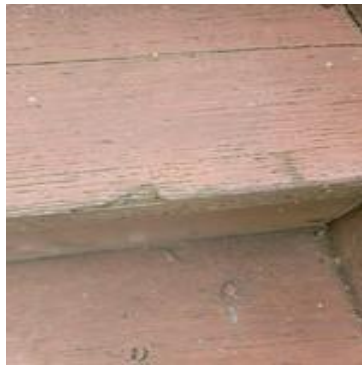
Picture 104: Surface of stairway

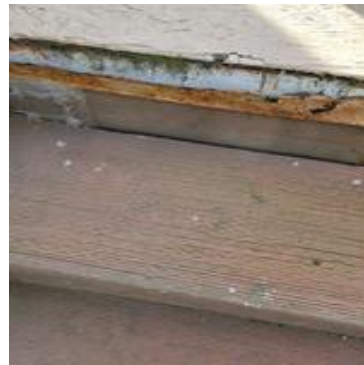
Picture 105: Surface of stairway

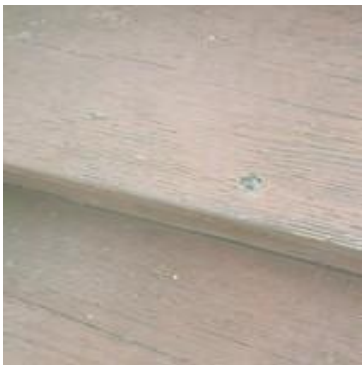
Picture 106: Surface of stairway

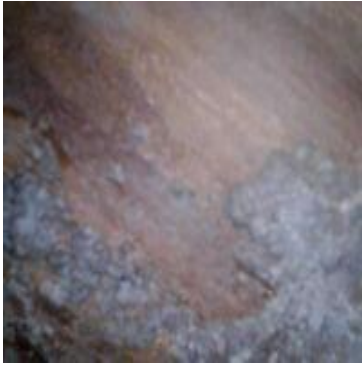
Picture 236: Wood Frame of stairway

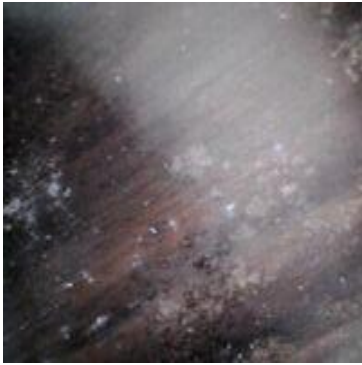
Picture 240: Wood Frame of stairway

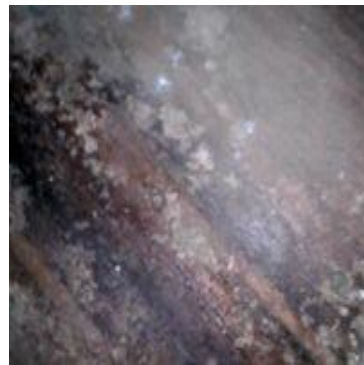
Picture 245: Wood Frame of stairway

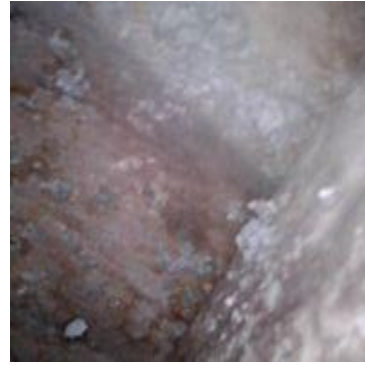
Picture 248: Wood Frame of stairway

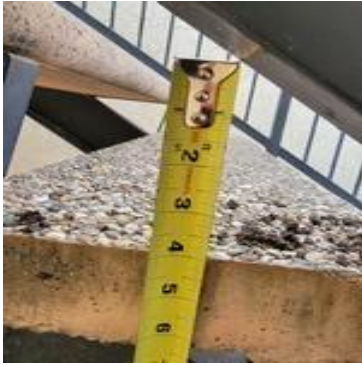
Picture 279: Railing of stairway

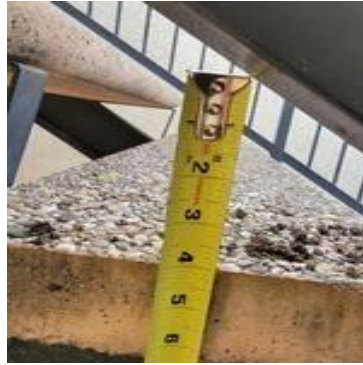
Picture 280: Railing of stairway

Identified defect (1): Railing56

Issue: Corrosion of the metal railing

Characteristics: Minimal corrosion and rust in isolated areas of the railing.

Impact: Limited impact on safety and aesthetics.

Recommendation: Remove visible rust, clean, and apply an anti-corrosion treatment to affected areas. Follow up with rust-resistant primer and touch-up paint.

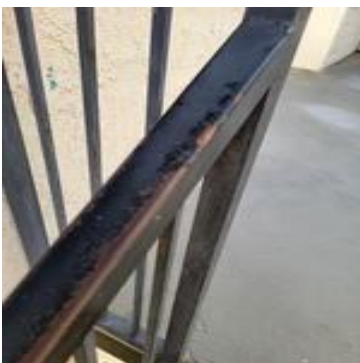
Picture 281: Railing of stairway
