2500 Red Hill Ave, Santa Ana, CA 92780

**Inspection Report of Exterior
Elevated Elements (EEE) According
to SB721**

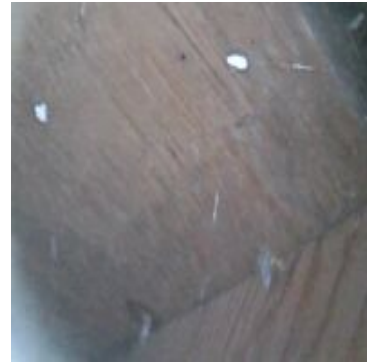
Picture 98 **(Defect Code: 147)**

Picture 99 **(Defect Code: 147)**

147	Wood frame damage	Fortunately, these issues are primarily cosmetic in nature and do not compromise the structural integrity of the wood.	<p>1. Visual Inspection: Thoroughly inspect the stringer/tread/riser for signs of wear, surface cracks, or discoloration. 2. Surface Treatment: Clean and lightly sand affected areas to remove surface imperfections. Apply a wood preservative or sealant to maintain the wood's integrity. 3. Regular Monitoring: Regularly monitor the condition of the stringer/tread/riser to ensure that minor damages do not escalate.</p>
122	Missing or Damaged Components of the railing	Moderate safety risk due to reduced structural integrity and compromised safety.	Conduct a comprehensive inspection to identify all missing or damaged components. replace them promptly with components that match the original design and safety specifications. Implement regular inspections and maintenance.

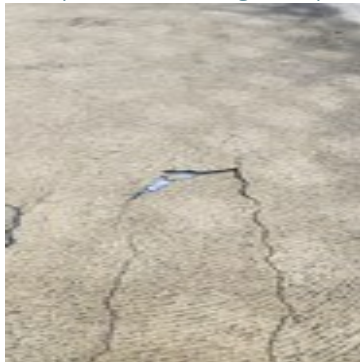
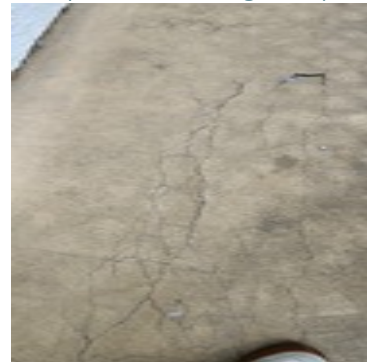
Picture 175 (**Defect Code: 19**)

Picture 176 (**Defect Code: 19**)

Picture 177 (**Defect Code: 19**)

19	Cracks/ Gaps on the surface	There is a moderate risk of moisture damage to the deck's substrate if left unattended.	Address these cracks and gaps promptly with appropriate sealants or fillers to prevent moisture intrusion. Regular inspections and maintenance every 6-12 months are necessary to monitor and maintain the condition of the deck.
35	Surface Insufficient	The deck may experience water-	Rectify the slope issue comprehensively, possibly involving adjustments to the entire

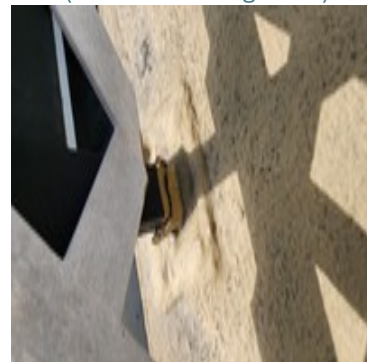
Picture 247 (**Defect Code: 109**)
[Link \(click to view High-Res\)](#)

recoat it with rust-resistant primer and paint. Consider reinforcing or replacing severely corroded sections.
109	Bolt/Screw Connections of the Railing to the Wood Frame Require Repair or Retrofitting (Insufficient lateral stability)	Minimal safety risk with instability in isolated areas.	Inspect and address unstable connections by tightening or replacing bolts/screws. Consider adding support brackets if needed. Implement routine inspections and maintenance.
113	Crack in Railing Post Connection to the Deck or Footing	Moderate safety risk due to reduced stability, with the potential for worsening over time.	Engineering Design: Develop engineering design plans and calculations based on the engineer's assessment to address the crack and ensure structural integrity. City Permit: Obtain the necessary permits from the city or local authorities for the repair or replacement of the railing post connection. Compliance with local building codes and safety regulations is essential. Certified General Contractor: Hire a certified general contractor with expertise in structural repairs and renovations to execute the engineering design plans and oversee the project. Comprehensive Repair or replacement: execute the recommended repairs, which may involve reinforcement or replacement of components, in line with the engineering design. Regular Inspections and Maintenance: Implement a regular inspection and maintenance schedule post-repair or replacement to ensure ongoing safety and compliance.

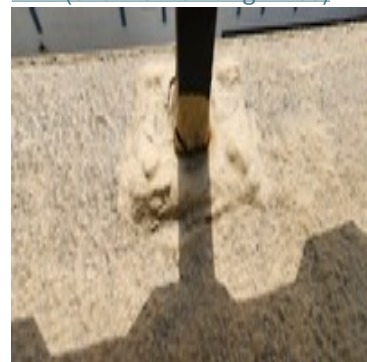
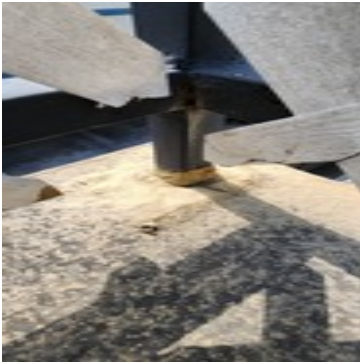
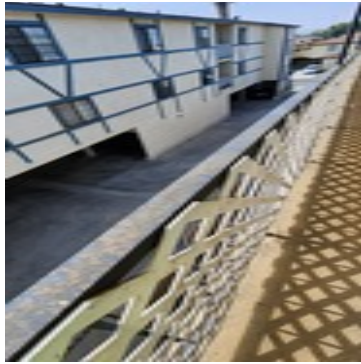
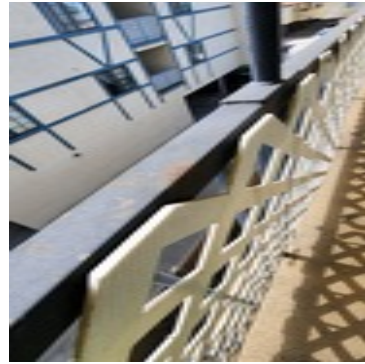
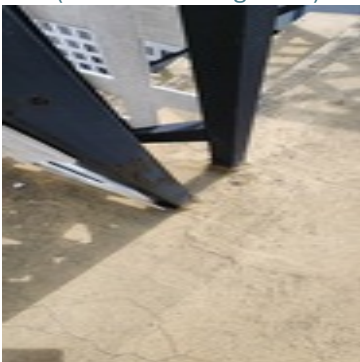
Picture 250 (**Defect Code: 101**)
[Link \(click to view High-Res\)](#)

Picture 251 (**Defect Code: 101**)
[Link \(click to view High-Res\)](#)

Picture 252 (**Defect Code: 101**)
[Link \(click to view High-Res\)](#)

Picture 253 (**Defect Code: 101**)
[Link \(click to view High-Res\)](#)

Picture 254 (**Defect Code: 101**)
[Link \(click to view High-Res\)](#)

Picture 255 (**Defect Code: 101**)
[Link \(click to view High-Res\)](#)

101	Corrosion of the metal railing	Moderate safety risk and diminished aesthetics.	Conduct a comprehensive cleaning and rust removal process for affected areas. Apply an anti-corrosion treatment, sand the railing, and

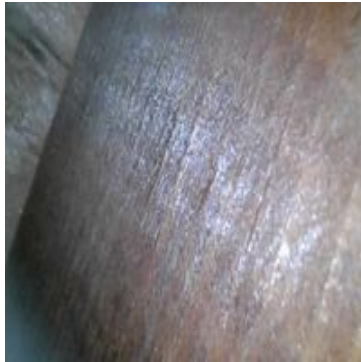
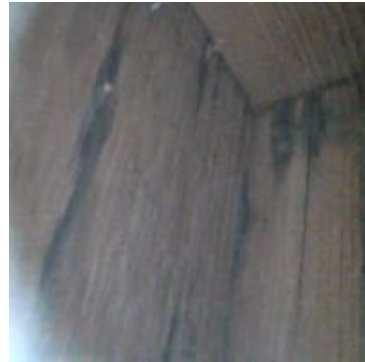
Picture 364 (**Defect Code: 202**)
[Link \(click to view High-Res\)](#)

Picture 365 (**Defect Code: 202**)
[Link \(click to view High-Res\)](#)

Picture 366 (**Defect Code: 202**)
[Link \(click to view High-Res\)](#)

202	Low level joist/rim joist/beam/ ledger defect		1. Visual Inspection: Thoroughly inspect joists and rim joists for signs of wear, surface cracks, or discoloration. 2. Surface Treatment: Clean and lightly sand affected areas to remove surface imperfections. Apply a wood preservative or sealant to maintain the wood's integrity. 3. Regular Monitoring: Regularly monitor the condition of joists and rim joists to ensure that minor damages do not escalate.
240	Shiner Bolts from Railing	Incorrectly connected shiner bolts can	1. Assessment and replacement: Engage a general contractor to thoroughly assess the
