2500 Red Hill Ave, Santa Ana, CA 92780

**Inspection Report of Exterior
Elevated Elements (EEE) According
to SB721**

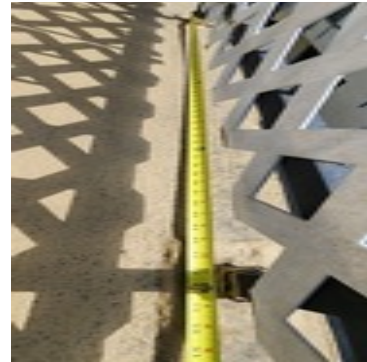
Picture 244 (**Defect Code: 122**)
[Link \(click to view High-Res\)](#)

Defect List				
Code	Type	Issue	Severity	Pictures of Identified Defects
122	Railing	Missing or Damaged Components of the railing	Moderate	Picture(s) 243,244
101	Railing	Corrosion of the metal railing	Moderate	Picture(s) 250,251,252,253,254,255
109	Railing	Bolt/Screw Connections of the Railing to the Wood Frame Require Repair or Retrofitting (Insufficient lateral stability)	Low	Picture(s) 247
113	Railing	Crack in Railing Post Connection to the Deck or Footing	Moderate	Picture(s) 248,249
19	Surface	Cracks/ Gaps on the surface	Moderate	Picture(s) 175,176,177
35	Surface	Surface Insufficient Slope	Moderate	Picture(s) 183
61	Surface	Discoloration of Surface	Moderate	Picture(s) 184,185,186,187,188
133	Waterproofing	Stucco discoloration underneath the EEE	Low	Picture(s) 271,272,273
137	Woodframe	Rotted/damaged decking or sheathing	Moderate	Picture(s) 357,358,359,360,361,362,363
202	Woodframe	Low level joist/rim joist/ beam/ ledger defect	Low	Picture(s) 364,365,366
